U.S. Department
of Transportation
**Federal Aviation
Administration**

ADVISORY CIRCULAR 43-16A

AVIATION MAINTENANCE ALERTS

ALERT
NUMBER
292

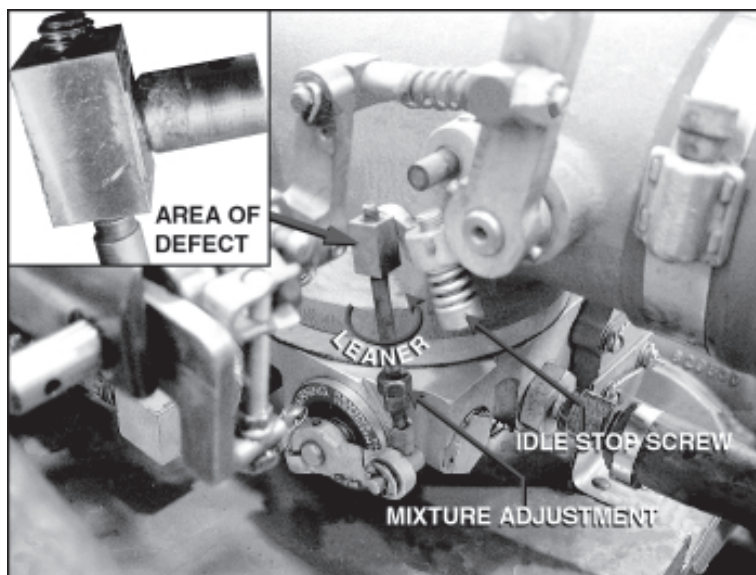
An investigation by a maintenance technician revealed severe galling on the mixture-control adjustment rod. The galling occurred where the rod attaches to the “throttle and control assembly” (P/N 640791A5) lever. (Refer to the illustration.) There was a significant amount of metal transfer, which prevented full movement of the throttle control.

The submitter stated it “appeared the throttle lever was made from a different type of material.” He recommended that technicians closely examine the mixture-control rod assembly during scheduled inspections.

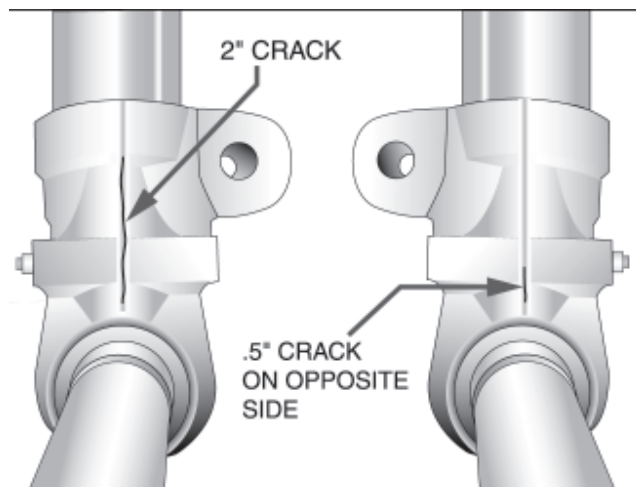
The NDI revealed a crack indication on both sides of one main gear piston/axle assembly (P/N 50-810318). One of the crack indications was approximately 2 inches long and the other was approximately .5 inch long. (Refer to the illustration.)

The submitter recommended that all concerned technicians give special attention to this area at every opportunity.

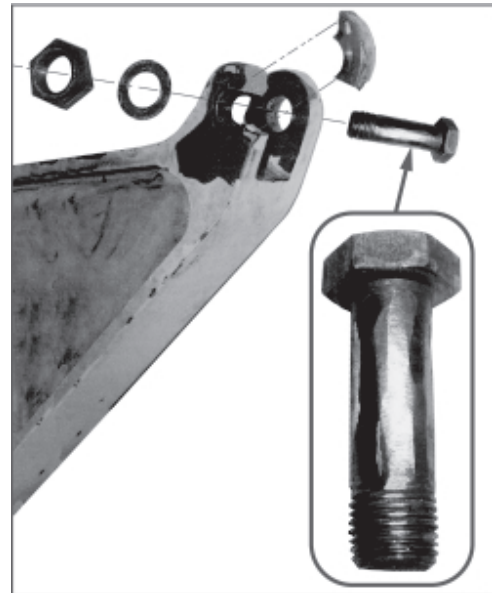
The arm (P/N 114-810026-1), which attaches to hydraulic actuator, had a broken ear. (Refer to the illustration.)

The submitter believes the damage occurred when an incorrect bolt was used during the original installation.

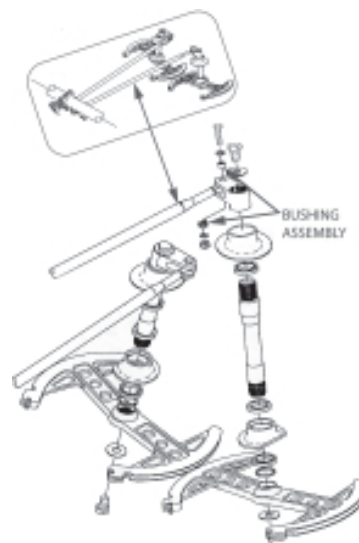
The technician discovered the elevator push-pull tube on the copilot’s side was binding during movement. He disassembled the tube rod-end and discovered that the two-part bushing (P/N 6760312-17 and P/N 6760312-25) was “frozen” to the bolt. (Refer to the illustration.) After he replaced the bushing assembly, the elevator system functioned normally.

The submitter suggested it would be wise to inspect this area closely at every opportunity.

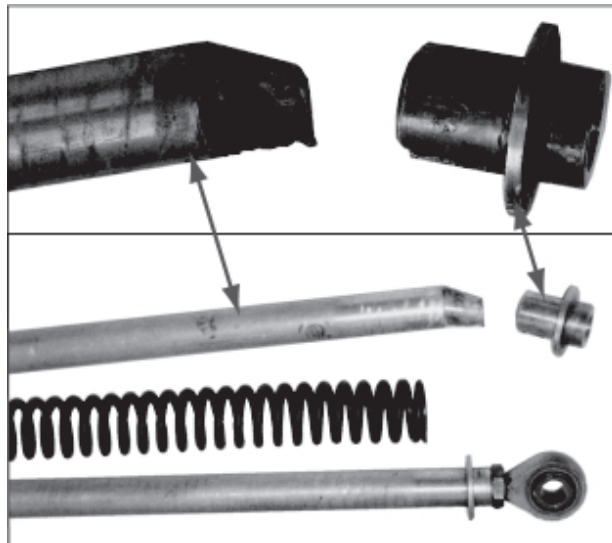
The extension rod (P/N 83699-003) contains a spring used to assist emergency extension of the nose gear. One end was broken where the rod-end fitting attaches. The submitter evaluated the evidence and concluded the rod-end fitting separated from the tube because of an “inferior weld” attachment. (Refer to the illustration.) Due to the spring loading of the rod assembly, failure of either end fitting causes “violent separation from the aircraft.”

Failure of the rod assembly may prevent extension of the nose gear. The submitter suggested that the manufacturer consider redesigning this part to be more structurally substantial for the intended purpose.
